Inspection of Arc Trails Formed in Stellarator/Heliotron Devices W7-X and LHD^{*})

Arc trails found in heliotron/stellarator devices Large Helical Device (LHD) and Wendelstein 7-X (W7-X) were inspected; arcing occurred on different locations at various situations. In LHD, a helium-plasma-induced tungsten nanostructure sample was installed and exposed to a LHD plasma. Many arc trails were formed only on the sample with nanostructures, suggesting an easy initiation of arcing compared to pristine tungsten. After the completion of annual campaign 2011 in LHD, arc trails appeared on a graphite divertor tile which was taken out for inspection. Because the arc trails had a linear shape, the arcing was likely caused by main discharge operation. In W7-X, some Langmuir-probes installed within the limiter tiles suffered severe damage with arc trails during the operational phase 1.1. After the operational phase 1.2b, in-vessel inspection was performed for the first time for all the plasma facing components focused on arcing. No arc trails appeared on graphite components including test divertor units. In turn, considerable number of the trails appeared on non-plasma exposed region. Most of the

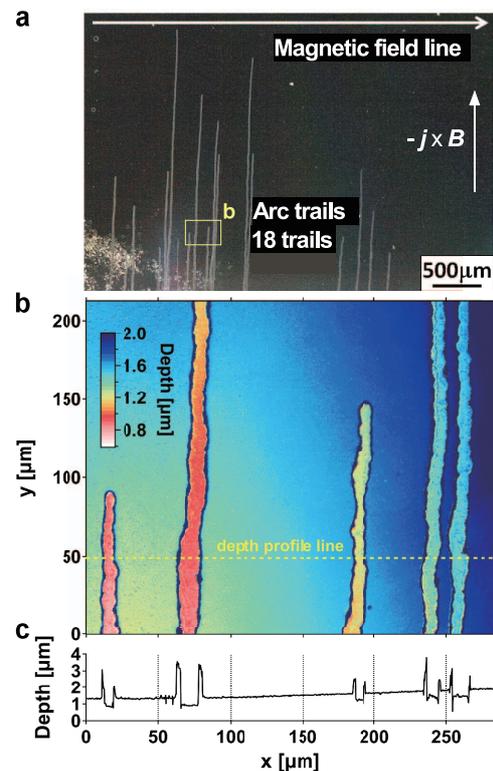
As a result, arcs ignited on the W-fuzz surface but not on the virgin W. Figure 2 (a) shows a digital microscope image of arc trails occurred on the W-fuzz surface. In total 18 trails were observed and they propagated along the opposite direction of the cross product of arc current and external magnetic field line $-\mathbf{j} \times \mathbf{B}$, so-called retrograde direction. Owing to much stronger magnetic field, the arc trails appeared with clear lines, which are different from the previous result showing zigzag motion at tenfold lower magnetic field [15].

Fig. 2 (a) A digital microscope image of arc trails remained on the W-fuzz surface, (b) a depth profile of several arc trails marked in (a), and (c) a depth line profile dashed in (b).

To estimate the erosion depth by the arcing, confocal laser microscopy was performed with the horizontal and vertical pitches of 277 nm/pixel and 100 nm/step, respectively. Figure 2(b) shows a depth profile of several arc trails. The region of interest is marked in Fig. 2(a). The width of the arc trails ranged 5-12 μm . Colorized trails clearly show that the arc trails were dented compared to the surrounding surface. Figure 2(c) shows a line depth profile at $y = 50\mu\text{m}$ in Fig. 2(b). Considering the gradient bulk surface, typical erosion depth by arcing was $\sim 0.4\mu\text{m}$. It is worth noted that the surrounding W-fuzz area was damaged by the plasma exposure, thus becoming thinner than the initial state of $\sim 1.4\mu\text{m}$. Compared to the previous research [11, 14], the erosion area appeared to be much smaller. One factor is linearity of motion, which reduced chances for the arc spots to stay longer around the surface. In addition, post-mortem observation confirmed that the strike-point of the plasma lied on an edge of the sample, implying lessened heat influx toward the fuzzy layer. From the Fig. 2, mass erosion by arcing was estimated as $\sim 0.5\mu\text{g}$. A vast majority of eroded materials were redeposited to the vicinity of the arc trails, as seen in Fig. 2(c). In addition to the small area eroded, this also resulted in smaller mass erosion compared to the previous research [14]. It is noteworthy that these arcs had mere effects on the plasma discharge and the discharge ended safely as planned.

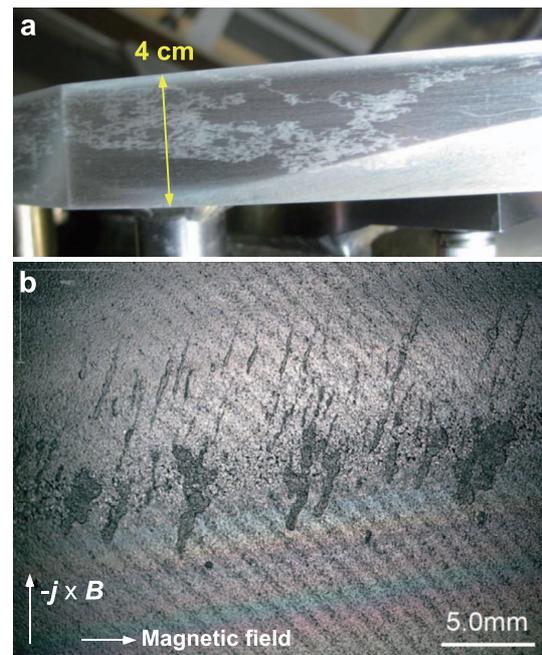
After the operation year 2011, several in-vessel components were taken out for inspection. Some were introduced already in the previous report [14], in which arc trails on an ECH mirror rear-side surface and a first wall panel were observed. Arc trails were also discovered on the other surfaces. Figure 3(a) shows an arc trail formed on the side surface of an ECH mirror. The arc trails were recorded broadly with area of roughly $\sim 1200\text{mm}^2$ and the morphology was not linear, indicating that the arc ignited in a non-magnetized environment.

Arc trails were also observed on a divertor module surface. Figure 3(b) shows a digital microscope image of arc trails recorded on a deposition layer of a divertor module. Several trails appear and the trail patterns show a certain orientation that is close to $-\mathbf{j} \times \mathbf{B}$ direction, implying that the arcing was initiated during main discharge under a strong magnetic field. Slight tilted propagation is likely because the surface normal was not exactly perpendicular to the magnetic field line that leads to tilted propagation of arc spots following the acute angle rule [17].

Fig. 3 (a) A photo of an arc trail on the side surface of an ECH mirror and (b) a digital microscope image of arc trails on a deposition layer of a divertor module.

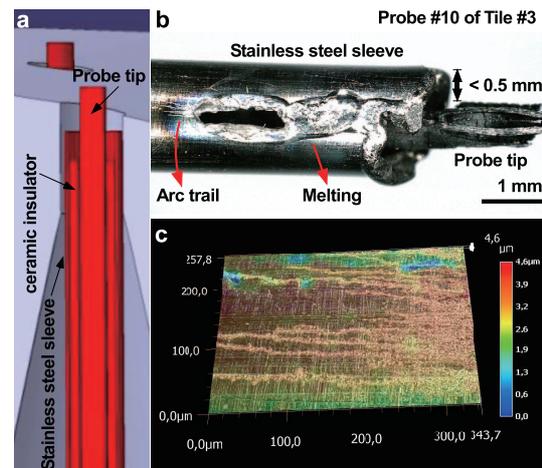
Fig. 4 (a) An illustration of the limiter module Langmuir probe, (b) a photo of a probe set with a damage on its graphite tip and a stainless sleeve and (c) a depth profile of the arc trail in (b). Note that the gray color image is superpositioned with the depth profile.

Among 40 probes in total, 4 probe tips suffered damages. Figure 4 (b) shows a photo of a damaged probe tip with melted SS sleeve. The graphite tip seemingly evaporated. On the SS sleeve, typical cathodic arc trails also appeared. The SS sleeve melting was primarily due to concentration of high current because of lack of in-built fuses in the power supplies. Figure 4(c) shows a depth profile of the arc trail by profilometry. A color scale bar indicates the height of the surface, which ranged 0 - 4.6 μm . The erosion depths of the trails were ~ 1 μm , which were smaller than the depths of arc spots in a previous study, which presented 4 - 40 μm of erosion depths on P92, martensitic-ferritic high temperature steel inserts in ASDEX-U [3].

Considering that graphite can evaporate when playing as an anode, arc ignition seemed to occur between the probe tip and the SS sleeve. However, at this moment it is unclear what originated such high current. It is worth noted that there was a blank space where the ceramic insulator was not filled between the probe tip and SS sleeve (See Fig. 4 (a)). The SS sleeves were grounded with the limiter modules, thus there was a triple metal-dielectric-vacuum junction, which usually regarded as the most common way of initiating vacuum breakdown [20]. Operational voltage range of the probe was ± 200 V [19]. It allowed the maximum electric field of 0.4 kV/mm between the probe rod and the SS sleeve with the gap distance 0.5 mm, however, which is yet lower than the minimal value generally required for vacuum breakdown of several kV/mm with the triple junction [21].

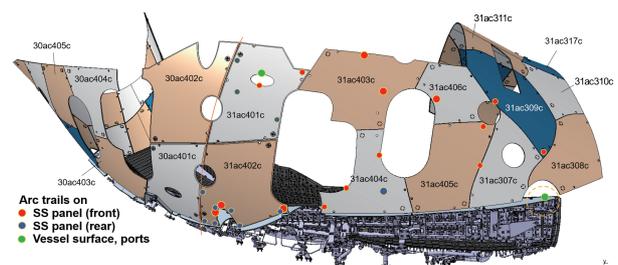
Fig. 5 Mapping of arc trail locations observed on the module 3 of W7-X.

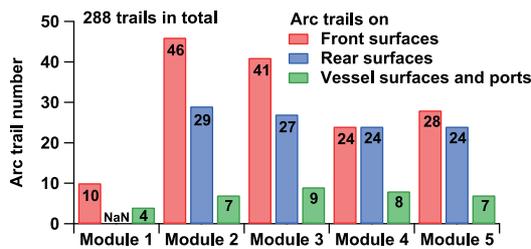
Fig. 6 The number distribution of arc trails on front, rear side SS panels and vessel and port surfaces for each module.

Figure 6 shows the number of arc trails classified by the locations for each module. On the front side surfaces, the number of arc trails varied. The largest amount was 46 trails recorded in the module 2, whereas the smallest number of 10 trails appeared in a neighboring module, the module 1. Rear side arc trails were distributed rather equally, ranging from 24 to 29 trails for each module. Note that rear side surfaces of the module 1 were not investigated. Less than 10 trails were on various ports and inboard side vessel surfaces.

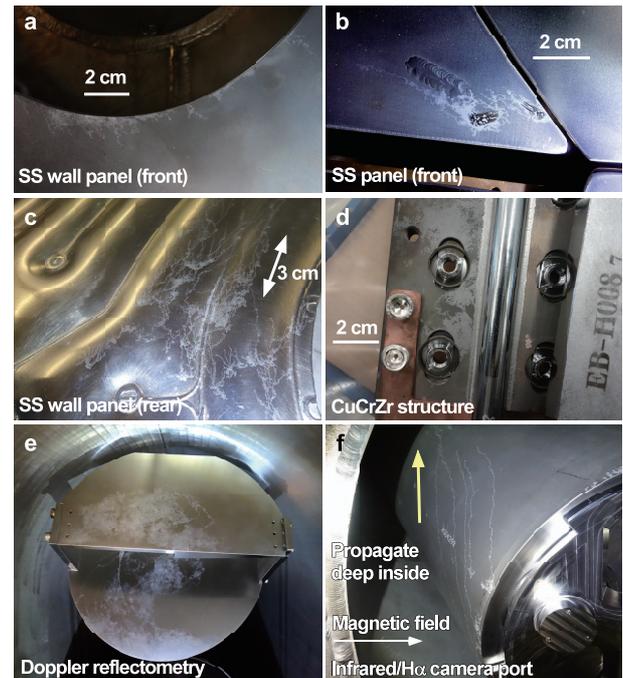
Figure 7 shows photos of arc trails by a digital camera. Figures 7 (a) and (b) show the arc trails formed on the front side of SS wall panels. Many trails with a length of $\sim 1-10$ cm initiated from edge or the interior of the panels. On the rear side of SS panels, arc trails tended to become broader. Figure 7 (c) shows arc trails recorded on the rear side of a SS panel. The trails were distributed with the length of ~ 30 cm and directed along the curvature of the panel surface while splitting into several branches. Figures 7 (d) and (e) show arc trails formed on a CuCrZr cooling structures and plates of Doppler reflectometry, respectively. For both cases, broad and planar trails were featured. Considering the morphologies of the arc trails, which showed broad, undirected and split motions of arc spots, and the locations of ignition on the rear side surfaces, it is likely that most of arc trails were formed during non-magnetized phases, i.e., glow discharge cleaning phase. On the other hand, some trails had clear orientation.

Fig. 7 Digital camera photos of arc trails on: (a)-(b) SS wall panels (front), (c) SS wall panel (rear), (d) CuCrZr cooling structure, (e) a surface of Doppler reflectometry plates and (f) a surface of infrared/ H_{α} camera insert.

Figure 7 (f) shows arc trails on the surface of infrared/ H_{α} camera port. Several arcs ignited near edges and propagated inside along the cylindrical surface. These trails show clear linearity, thus they could be affected by the external magnetic field. During the OP 1.2b, the general direction of the magnetic field was counter-clockwise looking from the top down to the torus, but operations with clockwise orientation were also performed. Therefore, there is a possibility of the arc ignition during the main plasma discharge.

PFCs. Therefore, erosion of PFCs and plasma contamination by arcing could be ignored. In turn, arc trails on diagnostics were observed and this can affect the precision and sustainability of diagnostics. Glow discharge cleaning is a necessary process prior to the main plasma operation. Therefore, arc ignition at the glow discharge should be prevented. Finishing the edges with a curved surface, polishing the dusty spots on mirror plates of diagnostics can be one method.

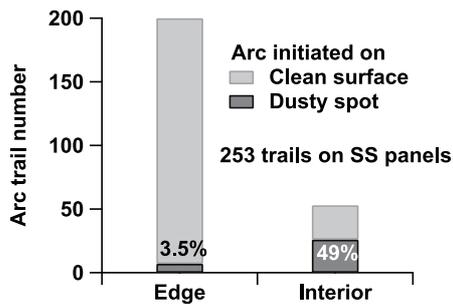
Arc initiation is usually related to electron emission processes including thermal emission, field emission (cold emission) and/or thermo-field emission taking both into account [20]. Therefore, it is reasonable to think that arcs can more easily ignite at the edges of surfaces, where field emission is enhanced due to locally intensified electric fields. Indeed, a majority of arc trails were detected at the edges of components, typically shown in Fig. 7 (a). Figure 8 shows the number of the arc trails classified by the location and the surface condition. Among 253 arc trails recorded on the SS wall panels, 79% occurred on the edges of the panels and 21% were on the interior of the surfaces. The interior has a planar surface and a flat electric field, thus arcing seems difficult to be initiated. It is noteworthy that almost half (49%) of the arc trails on the interior of the SS panels appeared with a deposition spot (dusty or weld spot, see an example in Fig. 7 (b)). On the other hand, the portion of arc trails with a dusty spot on the edge was only 3.5%. This result indicates that dusty spots acted as a seed

Fig. 8 Arc trail number classified by the location and the surface condition.

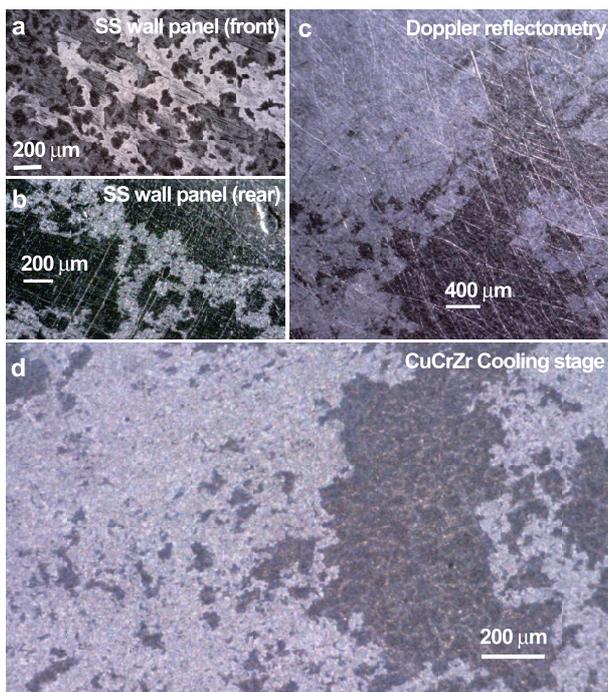
Fig. 9 Digital microscope images of arc trails on: (a) SS wall panel (front), (b) SS wall panel (rear), (c) a surface of Doppler reflectometry plate and (d) CuCrZr cooling structure.

One of the main effect of arcing on fusion devices is wall erosion. In detailed observation using a handy digital microscope (Dino-lite AM7915MZT), wall erosion by arc trails was detected. Figure 9 shows microscope images of arc trails on various surfaces, such as the front and the rear side of SS panels, surface of the Doppler reflectometry plate (see Fig. 7 (e)) and the CuCrZr cooling structure (see Fig. 7 (d)). It is noticeable that arc trails were sensitive to surface roughness. On rather rough surface as seen in Fig. 9 (a), the arc trails formed on a similar surface, avoiding black-colored dots. When a surface becomes smoother, arc trails also broadened as shown in Figs. 9 (b) and (c), where the plate of Doppler reflectometry was polished.
