Fatal Damages due to Breakdown on a Diagnostic Mirror Located outside the Vacuum Vessel in JT-60U^{*})

Some discharge phenomena seriously damaged the secondary mirror for Thomson scattering diagnostics, which was located outside the vacuum vessel. In this paper, the surface damages recorded on the mirror are observed in detail with an optical microscope. Many fine trails were found on the surface. The trails could be categorized into two different types with respect to the trail width. The mechanisms to lead the damages were discussed based on the observation. This study issues warning on the components to be installed in future fusion devices both inside and outside the vacuum vessel.

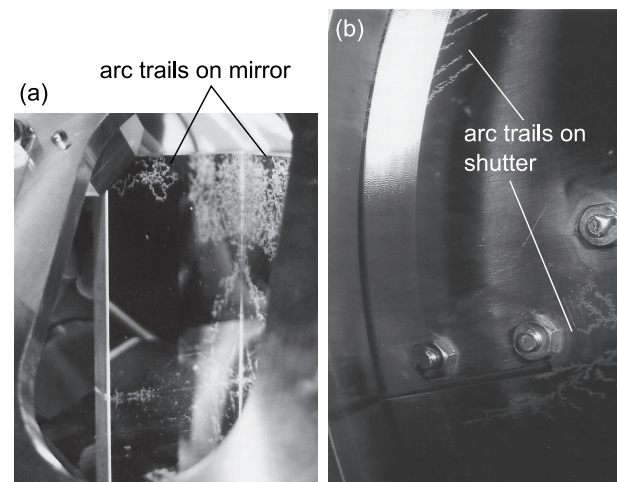
Arcing and breakdown phenomena have been observed not only on the divertor plate and first wall, but also on an in-vessel mirror [6], heating antenna [7], and so on. Shown in Figs. 1 (a) and (b) are arc trails recorded on corner cube retroreflector (CCR) and optical shutter in JT-60U, respectively. They were equipped inside the vacuum vessel. The CCR was composed of Zerodur and the surface was coated with gold, and the optical shutter was made of stainless steel. It is worth noting that the CCR was located on the upper diagnostic base of JT-60 and was several meters away from the plasma. It seems that the arcing has been frequently observed inside the vacuum vessel. However, arcing or breakdown phenomena take place not

Fig. 1 Pictures of arc trails recorded (a) corner cube retroreflector for interferometer measurement in JT-60U and (b) optical shutter for Thomson scattering system in JT-60U.

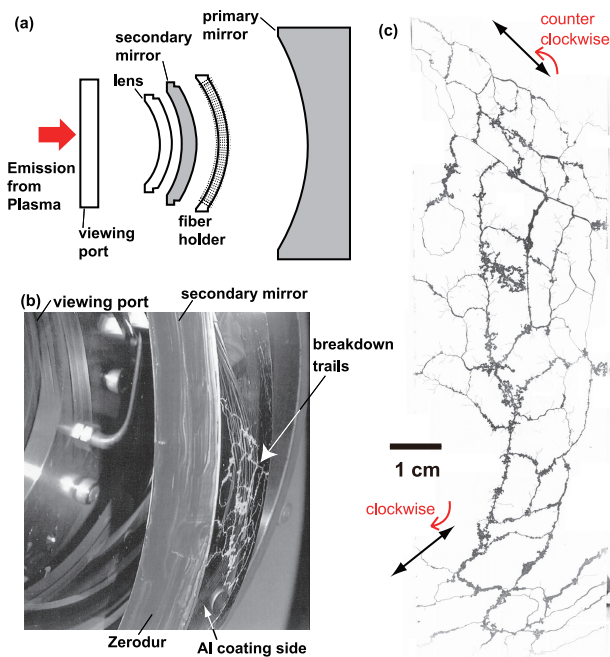
Fig. 2 (a) shows a schematic of the collection optics for Thomson scattering system in JT-60U. (b) shows a picture of the damaged secondary mirror. (c) The whole image of the surface damage observed with an optical microscope.

Figure 2 (a) shows a schematic of the collection optics for Thomson scattering system in JT-60U [8, 9]. In Fig. 2 (a), scattered photons, which come from the left hand side, pass through a viewing port and lens, and they are transferred with primary and secondary mirrors and collected with optical fibers equipped on a holder. The optics is located in between the toroidal coils, where a strong magnetic field should exist during discharges. Figure 2 (b) shows a picture of the damaged secondary mirror, which was installed in 1991. The picture was taken from the primary mirror side, and the plasma existing area is over the viewing port seen in the left part in Fig. 2 (b). The damage on the surface was found in November 1999, and the mirror was replaced in the next year. It is highly possible that the damage was formed within several months before the finding, because detailed checks of the optics had been conducted constantly. The base material of the secondary mirror was Zerodur, which is a glass-ceramic made by Schott AG. One of the advantages of Zerodur is low (nearly zero) thermal expansion around the room temperature. The surface was covered with a protection coating in addition to an aluminum coating on Zerodur. Because the protection coating layer was an insulator, it was likely that the aluminum layer was not connected anywhere electrically.

The surface of the damaged secondary mirror was observed by an optical micrograph (VCR800, Omron Co.). Figure 2 (c) shows a whole image of the surface damage. For the observation using an optical micrograph, it

was technically important how to illuminate the object. In Fig. 2 (c), the object was illuminated from the backside in a dark room. Because Zerodur is optically transparent and aluminum reflects light, the damaged part, where aluminum coating was removed, can be clearly identified by illuminating from the backside. It is seen that many lines run up and down and bridges between the longitudinal lines are formed; moreover, bifurcations occur frequently. From the shape of bifurcated trails, the phenomena could be categorized to electrical treeing.

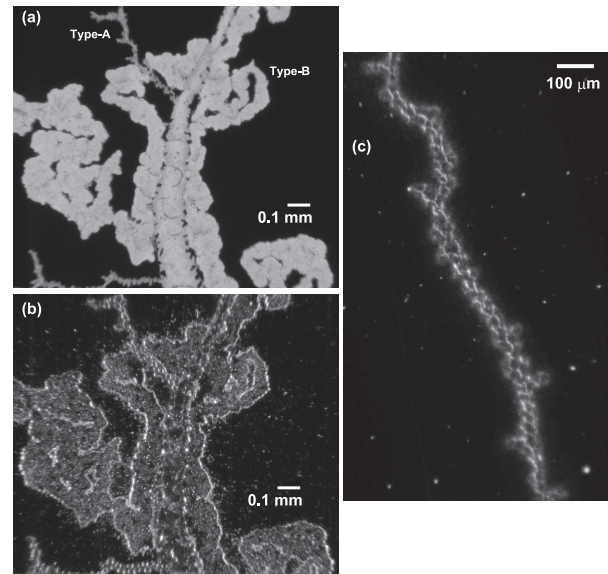
Fig. 3 Detailed pictures of the trail. The object was illuminated from the backside in (a), while it was illuminated from the front side in (b). (c) an enlarged images of type-A trail.

Figures 3 (a) and (b) show detailed pictures of the trail, where the mirror was illuminated from the front side. It is identified that there exist two different types of trail with respect to the trail width. They are called as type-A and type-B in this paper: type-A with the trail width of $\sim 30\text{--}40\ \mu\text{m}$ and type-B with the width of $\sim 60\text{--}70\ \mu\text{m}$. Short bifurcated trails correspond to type-A, while major trails seem to be composed of type-A and type-B. Figure 3 (c) is an enlarged image of the type-A trail. It is identified that the trail is composed of many small footprints. The characteristics are similar to arc trails. Usually, for arcing, trail is formed in the process of repetitive re-ignition of arc spot [10]. It is thought that type-A trails were formed by the motion of spots.

From the trail observed in Fig. 3 (c), it seems that the part of the trail is formed by the re-ignition process of an arc spot. It is noted that since no material that can be another electrode existed near the mirror, the arcing corresponds to unipolar arc, in which a plate plays roles of both cathode and anode. Once a plasma is formed on the surface, unipolar arc can be sustained by forming a current loop locally, as described in Schwirzke's model [14]. In that sense, it might be possible that the plasma had two different footprints, namely, cathodic and anodic footprints. It is suspected that the type-A and type-B trails shown in Fig. 3 correspond to the cathodic and anodic footprints, respectively. However, it is unknown whether and why the electric field to initiate unipolar arcing was formed.

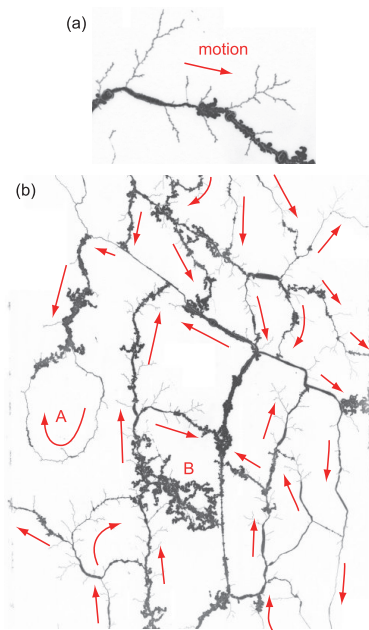
Figure 4 (a) shows a micrograph of the trail on the surface. From the direction of the treeing, we can determine the direction of the motion of the spot. For the case of Fig. 4 (a), the spot would have been moved from left to right, because the treeing grew toward the right direction. In Fig. 4 (b), the direction of the motion identified from the direction of treeing are presented as arrows. The directions are not unique, but rather random. Moreover, at location A

Fig. 4 Optical microscope images of the trail on the surface. The directions of the motion is depicted as arrows.

in Fig. 4 (b), the spot turned around clockwise. At location B in Fig. 4 (b), the trail shows fractal-like feature, indicating that the spot seemed to move very randomly. Although variation of fractality in a trail has been observed recently at the terminal point of an arc spot [11], the fractality of an arc trail is basically determined by the magnetic field strength. In Fig. 4 (b), on the other hand, the trail is mainly composed of sharp lines with treeing, and sometimes fractal-like feature appears on the trail. Such a mixed feature cannot be usually seen on a trail of arcing.

tric resistance. If the strength of the electric field exceeded the creepage resistance, the flashover discharge could be initiated. Considering the fact that the trail had various directionalities, a complicated structure, and loops, as shown in Fig. 4 (b), it was thought that the induced current might play roles to initiate flashover discharge.
