Inspection of Arc Trails Formed in Stellarator/Heliotron Devices W7-X and LHD^{*})

Arc trails found in heliotron/stellarator devices Large Helical Device (LHD) and Wendelstein 7-X (W7-X) were inspected; arcing occurred on different locations at various situations. In LHD, a helium-plasma-induced tungsten nanostructure sample was installed and exposed to a LHD plasma. Many arc trails were formed only on the sample with nanostructures, suggesting an easy initiation of arcing compared to pristine tungsten. After the completion of annual campaign 2011 in LHD, arc trails appeared on a graphite divertor tile which was taken out for inspection. Because the arc trails had a linear shape, the arcing was likely caused by main discharge operation. In W7-X, some Langmuir-probes installed within the limiter tiles suffered severe damage with arc trails during the operational phase 1.1. After the operational phase 1.2b, in-vessel inspection was performed for the first time for all the plasma facing components focused on arcing. No arc trails appeared on graphite components including test divertor units. In turn, considerable number of the trails appeared on non-plasma exposed region. Most of the

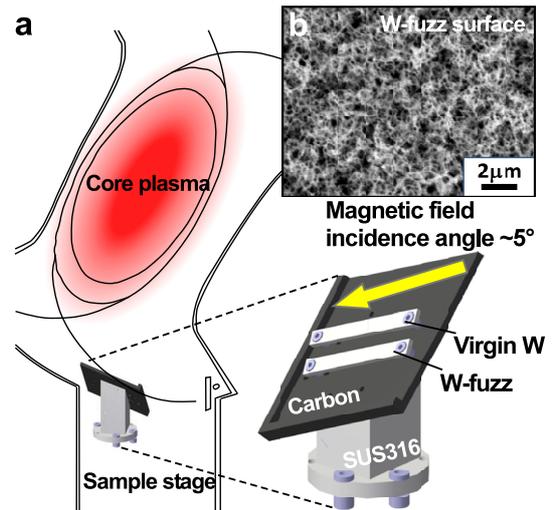
Two W samples ($10 \times 80 \times 3 \text{ mm}^3$) were prepared and one was exposed to a He plasma of the linear magnetized divertor simulator NAGDIS-II (Nagoya Divertor Simulator) for W-fuzz formation on the surface (W-fuzz in Fig. 1 (a)). The exposure followed the formation condition of fuzz [8] and the ion fluence ($\sim 10^{25} \text{ m}^{-2}$) was set to give approximate W-fuzz thickness of $1.4 \mu\text{m}$. Figure 1 (b) shows a scanning electron microscopic (SEM) image of the W-fuzz sample, which presents typical fuzz growth on the surface. The other was kept pristine as a control (Virgin W in Fig. 1 (a)). The samples were installed on a sample holder and then inserted inside the vacuum vessel of LHD. Figure 1 (a) shows a schematic sketch of the W-fuzz manipulator probe. The samples were electrically isolated from the sample holder. The sample surfaces were tilted 5° from the orientation of magnetic field lines. The experiment was performed for one hydrogen discharge. The discharge duration was $\sim 1.5 \text{ s}$ and the electron density at the core was $3 - 4 \times 10^{19} \text{ m}^{-3}$. Magnetic field at core was the 2.75 T.

Previously, W-fuzz samples were installed in LHD and an arcing occurred on its surface [11, 14]. The sample surfaces were oriented perpendicular to the magnetic

Fig. 1 (a) A schematic sketch of a W-fuzz sample mounted on a manipulator probe in LHD (b) an SEM micrograph of the W-fuzz sample.

field lines. Thus, there was no effective $-\mathbf{j} \times \mathbf{B}$ directivity and the arc spots moved in a random manner. Considering the small contained angle (several degree) between a divertor surface and incident magnetic field lines in future devices like ITER [16], the straightforward arc trails in this research suggests probable movement of arc spots in the divertor modules. It should be noted that there was
