Progress of Gamma Ray Irradiation Experiments on ITER Diagnostics from JADA^{*)}

The Japan domestic agency (JADA) is responsible for procuring five diagnostic systems for ITER: the microfission chamber (MFC), poloidal polarimeter (PoPola), edge Thomson scattering (ETS), divertor impurity monitor (DIM), and divertor infrared thermography (IRTh) systems. Components of these systems that will be installed in high radiation zones must undergo radiation resistance tests to ensure reliability. The JADA diagnostic group has been conducting gamma ray irradiation experiments on diagnostic components at QST since 2018. The MFC is a neutron diagnostic system that uses uranium fission chambers, the mineral-insulated cables of which were evaluated for corrosion resistance. In-situ observations of the MFC preamplifier have been launched. The PoPola provides the plasma current profile by detecting the polarizations of far-infrared laser beams at their inlets and outlets. Irradiation tests confirmed the durability of PoPola piezo actuators. The ETS is a laser-aided diagnostic to measure electron temperature and density in plasmas from scattered spectra. Laser-induced damages to the optical elemen

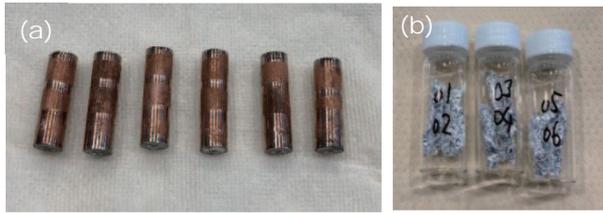
Fig. 2 MI specimens for gamma irradiation. (a) Cut MI cables (b) Specimens wrapped in Al placed in vials.

Specimens of the MI cable were cut to 6.6 mm in diameter and 40 mm in length, wrapped in aluminum foil so as not to spill the insulating material, and placed in a vial (30 mm in diameter \times 70 mm in height). Figure 2 shows the samples prepared for irradiation at a dose rate of 1.7 kGy/h up to 1 MGy. SEM observations of the samples before and after irradiation did not show any change except for slight oxidation of the outer copper coating.
