Evaluation of Carbon Erosion Process in Attached and Detached Deuterium Plasmas

Carbon material, which is the candidate material of the divertor in the fusion reactor, would be damaged significantly in a detached plasma since a carbon has high reactivity with a hydrogen isotope. It is of importance in the investigation of the fundamental characteristics of carbon-hydrogen interaction. In this study, Highly Oriented Pyrolytic Graphite (HOPG) was exposed to the attached and detached deuterium plasmas in the NAGDIS-T. By surface analysis using scanning electron microscopy (SEM) and Raman spectroscopy, it was found that the HOPG irradiated with the detached plasma has anisotropic damages. The anisotropic characteristics of graphite erosion are discussed on the basis of the results of the comparison with molecular dynamics (MD) simulation.

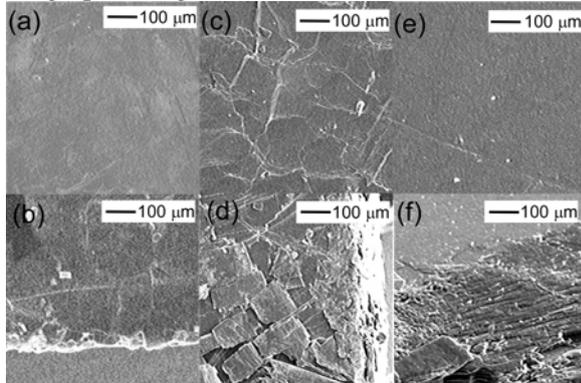
Fig.1. SEM photographs of the surface of HOPG target. (a) and (b) show the nonirradiated target in the central and edge parts, (c) and (d) show the irradiated target with the attached plasma in the central and edge parts, and (e) and (f) show the irradiated target with the detached plasma in the central and edge parts.

Figures 1(a)-(f) were SEM micrographs of the central and edge areas of the HOPG samples before irradiation and after the attached and detached plasma irradiation, respectively. It was found that, after the irradiation with the detached plasma, the center of the HOPG target had no damage and the peripheral region of the target was damaged and showed a staircase pattern, as shown in Figs. 1(e) and 1(f). This suggested that the edge area of the HOPG target was mainly damaged when the incident ion energy was low. The edge of the graphene sheet is thought to be weaker than the central area for low-temperature deuterium plasma irradiation. Figure 2 shows the Raman spectral analysis results for the nonirradiated and irradiated HOPG samples in terms of I_D/I_G and $\text{FWHM}_G[1]$. A part of surface of the HOPG sample irradiated with the attached plasma became visually darker than its

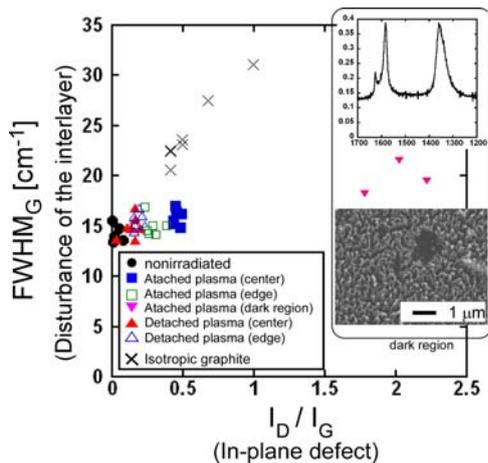
Fig.2. $FWHM_G$, which corresponds to disturbance of the interlayer, as a function of the intensity ratio (I_D / I_G), which corresponds to in-plane defects of nonirradiated, and irradiated HOPG targets.

margin and seemed to have more in-plane defects than isotropic graphite. The dark area seemed to be protrusion-like structure, as seen in the SEM micrograph in Fig. 2.

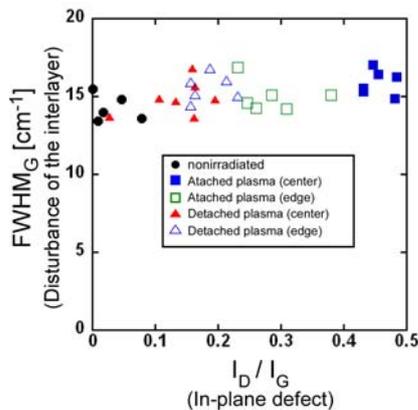
Fig.3. Enlarged diagram of Fig. 2 except for the results of visually dark region and isotropic graphite. Thus, the dark area seemed to be severely

damaged by irradiation with the attached plasma comparing with its margin. Figure 3 shows the enlarged diagram of Fig. 2 excluding the results of the dark area and isotropic graphite. The HOPG irradiated with the attached plasma was observed to have more in-plane defects than that irradiated with the detached plasma. As for the irradiation with the detached plasma, the edge region had particularly in-plane defects. In the same manner as the results from SEM photograph, the HOPG target is likely to be damaged from the edge of a graphene sheet at a low ion incident energy.
