Optical Spectroscopic Measurement during CFRP Irradiation and its Surface Observation

CFRP材へのプラズマ照射時の分光計測と表面状態の変化

Yuma Hatada¹, Kento Kohmatsu¹, Naomichi Ezumi¹, Takuro Matsumine², Akira Tada²
畑田優馬¹, 幸松健人¹, 江角直道¹, 松峯拓郎², 多田晃²

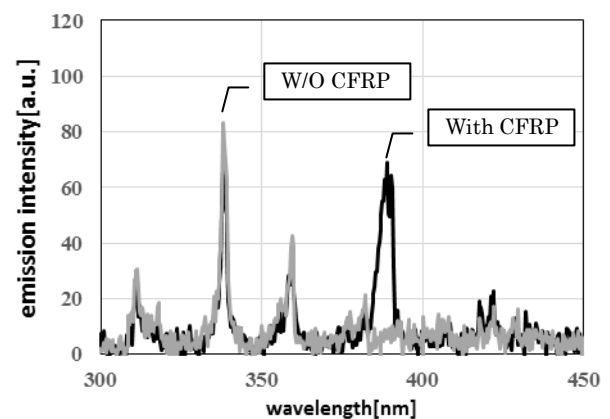
Fig 2. Change of emission spectrum (with and without CFRP)

As shown in Figure 1, SEM images clearly indicate that removals of plastic components from CFRP by plasma irradiation. These results suggest us that the possibility of repairing CFRP using plasma. Figure 2 shows the emission spectrum during plasma irradiation on CFRP. A line emission around 388nm is appeared during CFRP irradiation. The origin seems to be plastic components of
