## 機能性セラミックス被覆の流動リチウム鉛合金中 腐食挙動

# Corrosion behavior of functional ceramic coatings in flowing lithium-lead alloy

近田 拓未<sup>1</sup>、赤星 江莉加<sup>1</sup>、芦田 真奈<sup>1</sup>、八木 重郎<sup>2</sup>、Schroer Carsten<sup>3</sup>、他 Takumi Chikada<sup>1</sup>, Erika Akahoshi<sup>1</sup>, Mana Ashida<sup>1</sup>, Juro Yagi<sup>2</sup>, Carsten Schroer<sup>3</sup> et al.

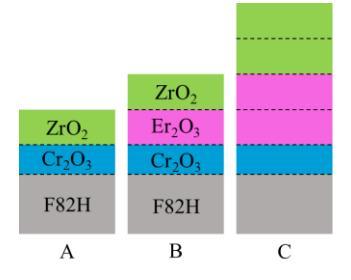
Fig. 1 Layer structure of coating samples.

Reduced activation ferritic/martensitic steel F82H (Fe-8Cr-2W, F82H-BA07 heat) plates were used as substrates. The coating procedure including formation of chromium oxide ( $Cr_2O_3$ ) on the substrate, dipcoating of zirconium oxide ( $ZrO_2$ ) and erbium oxide ( $Er_2O_3$ ) coating precursors, drying, pre-heat treatment, and heat treatment is described in detail in Ref. [2]. The layer structures of the coatings are presented in Fig. 1. The heat treatment was performed every time after dipping, drying, and pre-heating of each layer.
